Manhole Inspection Summary

Manhole # S41A__010MH

Inspection ☐ Is Incomplete Rating: **3) Fair**

Location Address: **500 n caroline st** Cross Street: **2nd parking lot**

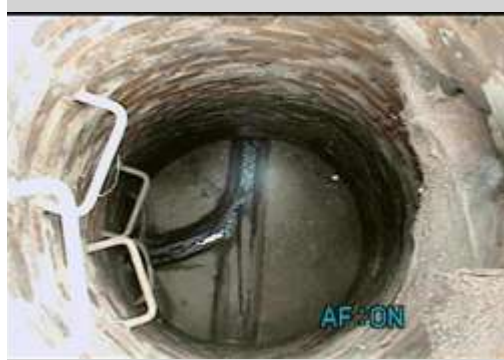
Top View

top view & steps

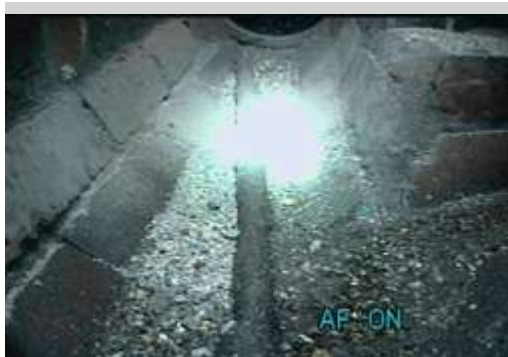
Defect 3

Condition: ☐ Sound ☐ Cracked ☐ Root Intrusion ☐ Deteriorated ☐ Leaks ☒ **Debris**

channel debris

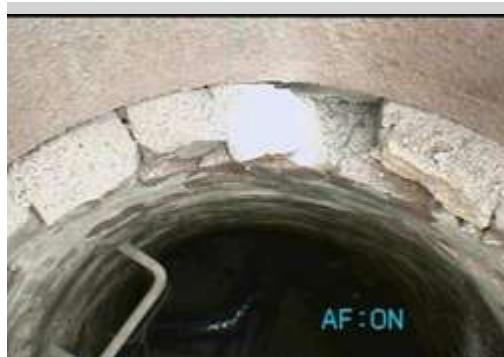
Defect 2

Frame Offset: **2.5** (in.) Condition: ☒ Sound ☐ Cracked ☐ Leaks

offset

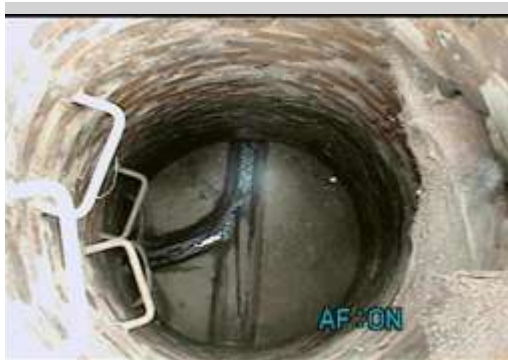
Defect 4

Steps Count: **7** Missing: **0** ☒ **Corroded**

steps

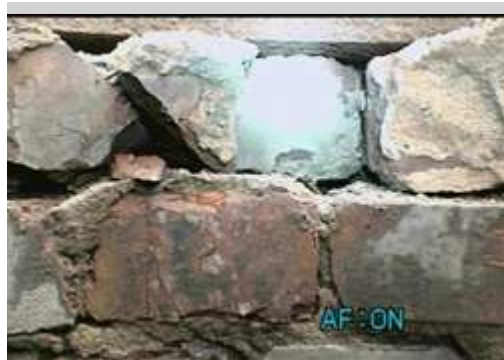
Defect 1

Condition: ☐ Sound ☒ **Cracked** ☐ Root Intrusion ☒ **Loose Brick** ☒ **Deteriorated**

corbel condition loose bricks, cracked, deteriorated,

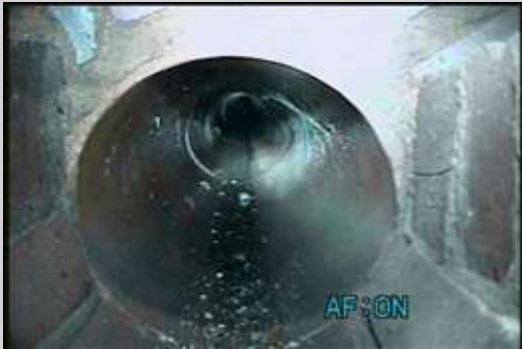
12 O'Clock Outflow

Infiltration: **Evidence** Pipe Seal Cond: **Unknown**

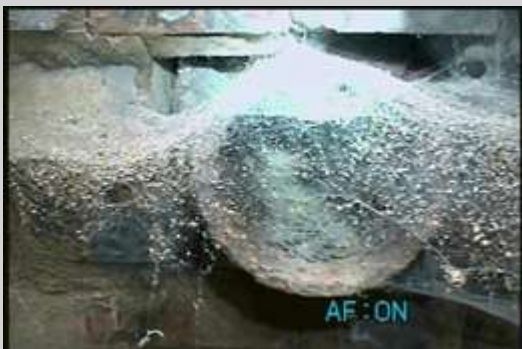
2 O'Clock Inflow

break-in
